## KAIKOURA RAIL & ROAD REBUILD

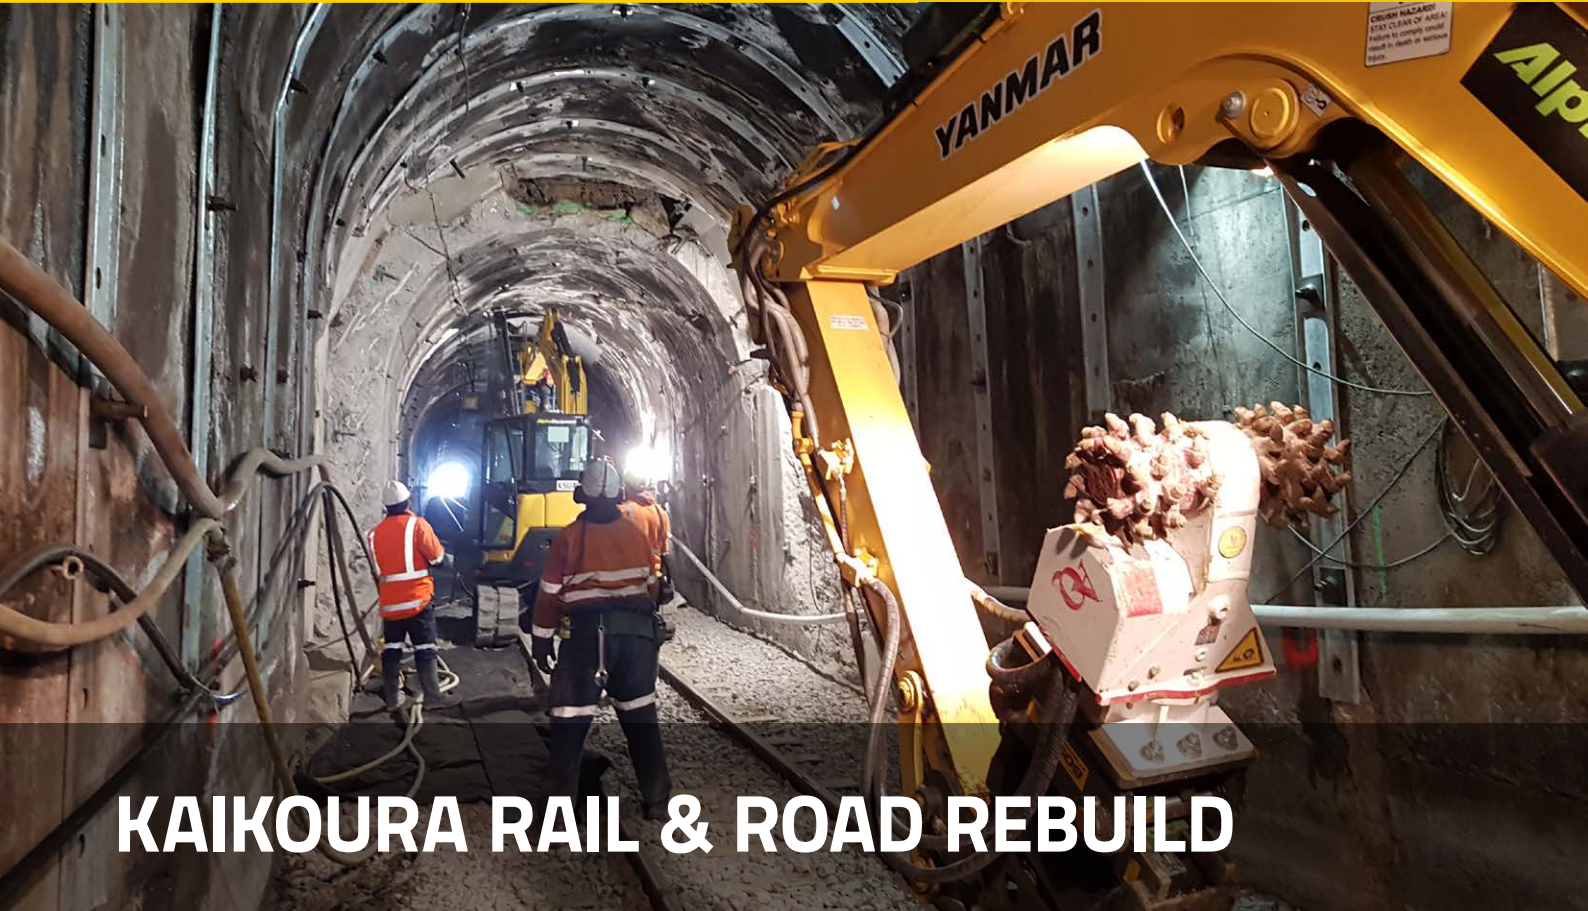
With a focus on avoiding any further compromise to the existing and structural integrity of the tunnels due to vibration, this led to the initial selection of the baby AQ1s (120kg) milling head mounted on an 8 tonne excavator to mill back the concrete tunnel linings and the raw blue greywacke walls.

The benefits of utilizing these small robust Antraquip Milling Heads is that there is little or no micro cracking of the area outside the excavation line (Cracking from hammers and other excavation methods has been shown to reach up to 2m) and this made them an ideal option for this particular remediation challenge

Two of the range's smallest units – an AQ-1s and AQ-1 – were utilised on the project over a period of 2 years.
